STATE OF WASHINGTON  
DEPARTMENT OF ECOLOGY  
Water Resources Branch

A Report on the Geology  
and Ground-Water Resources  
of Land Parcel No. 1-2680  
owned by Charles Puckett,  
Snohomish County, Washington

By  
Paul A. Eddy  
1971

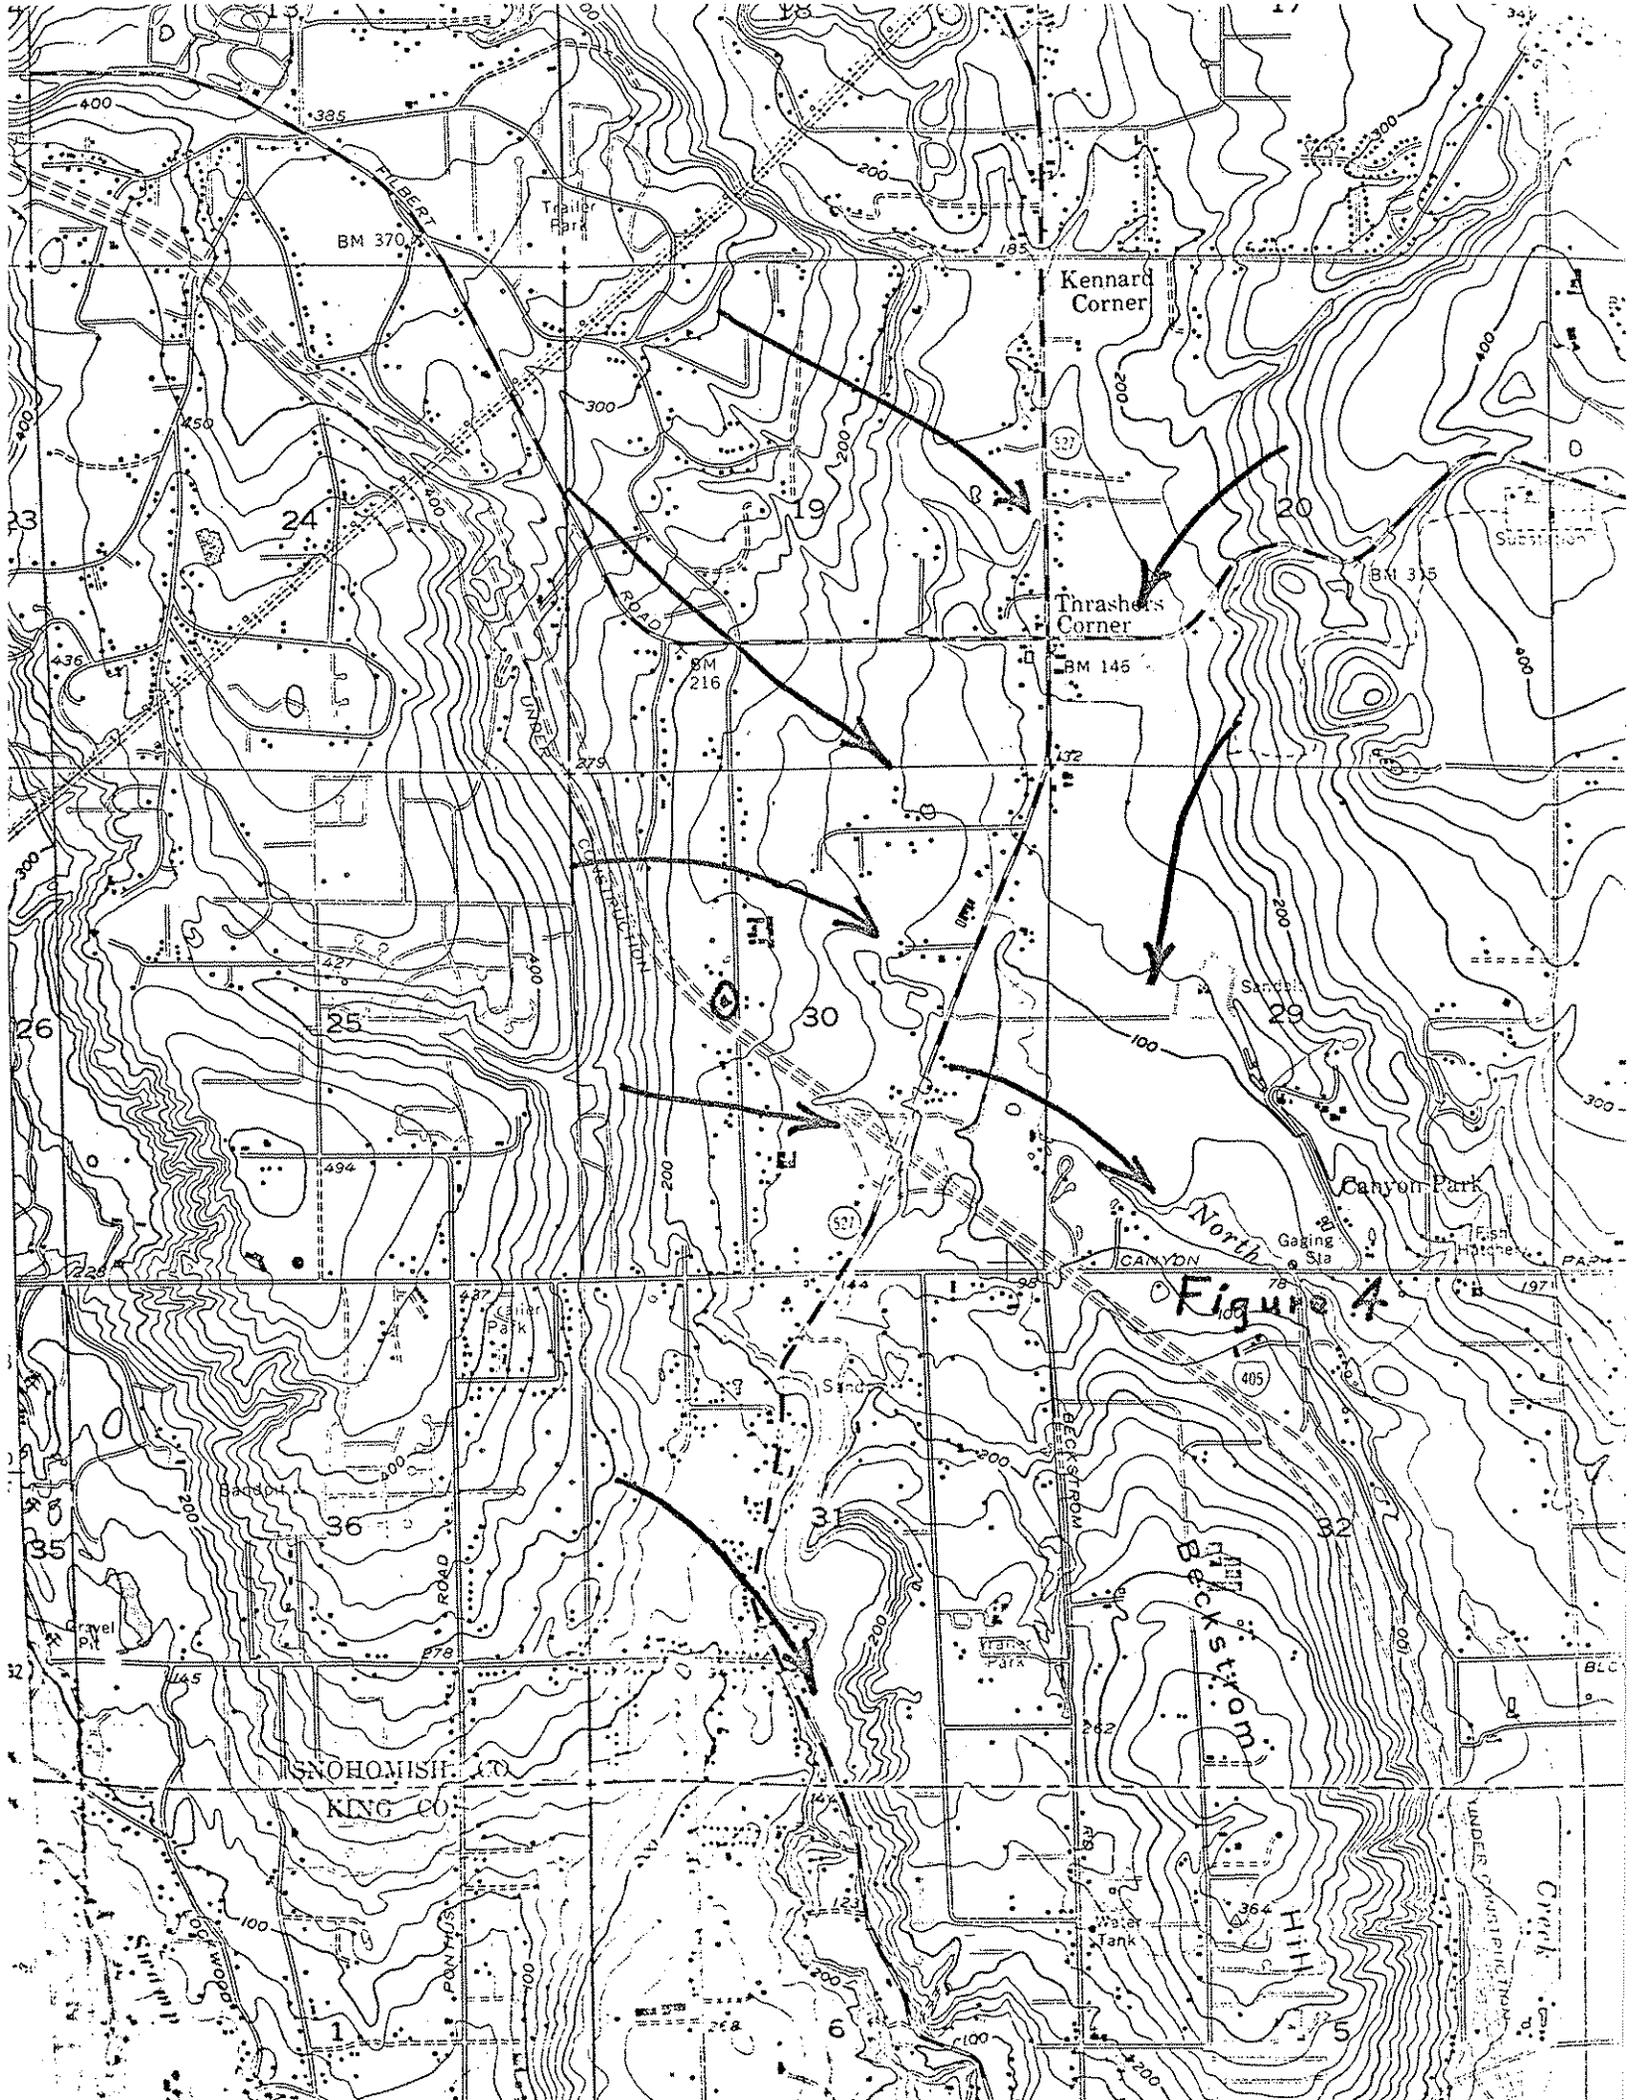
The direction of ground-water flow before construction is shown on figure 4 and if compacting because of highway construction occurred within the aquifer the present flow lines are shown on figure 5. Only where large amounts of fill material was required could we expect compaction within an aquifer to occur. Apparent ground-water flow on the property is shown on figure 6.

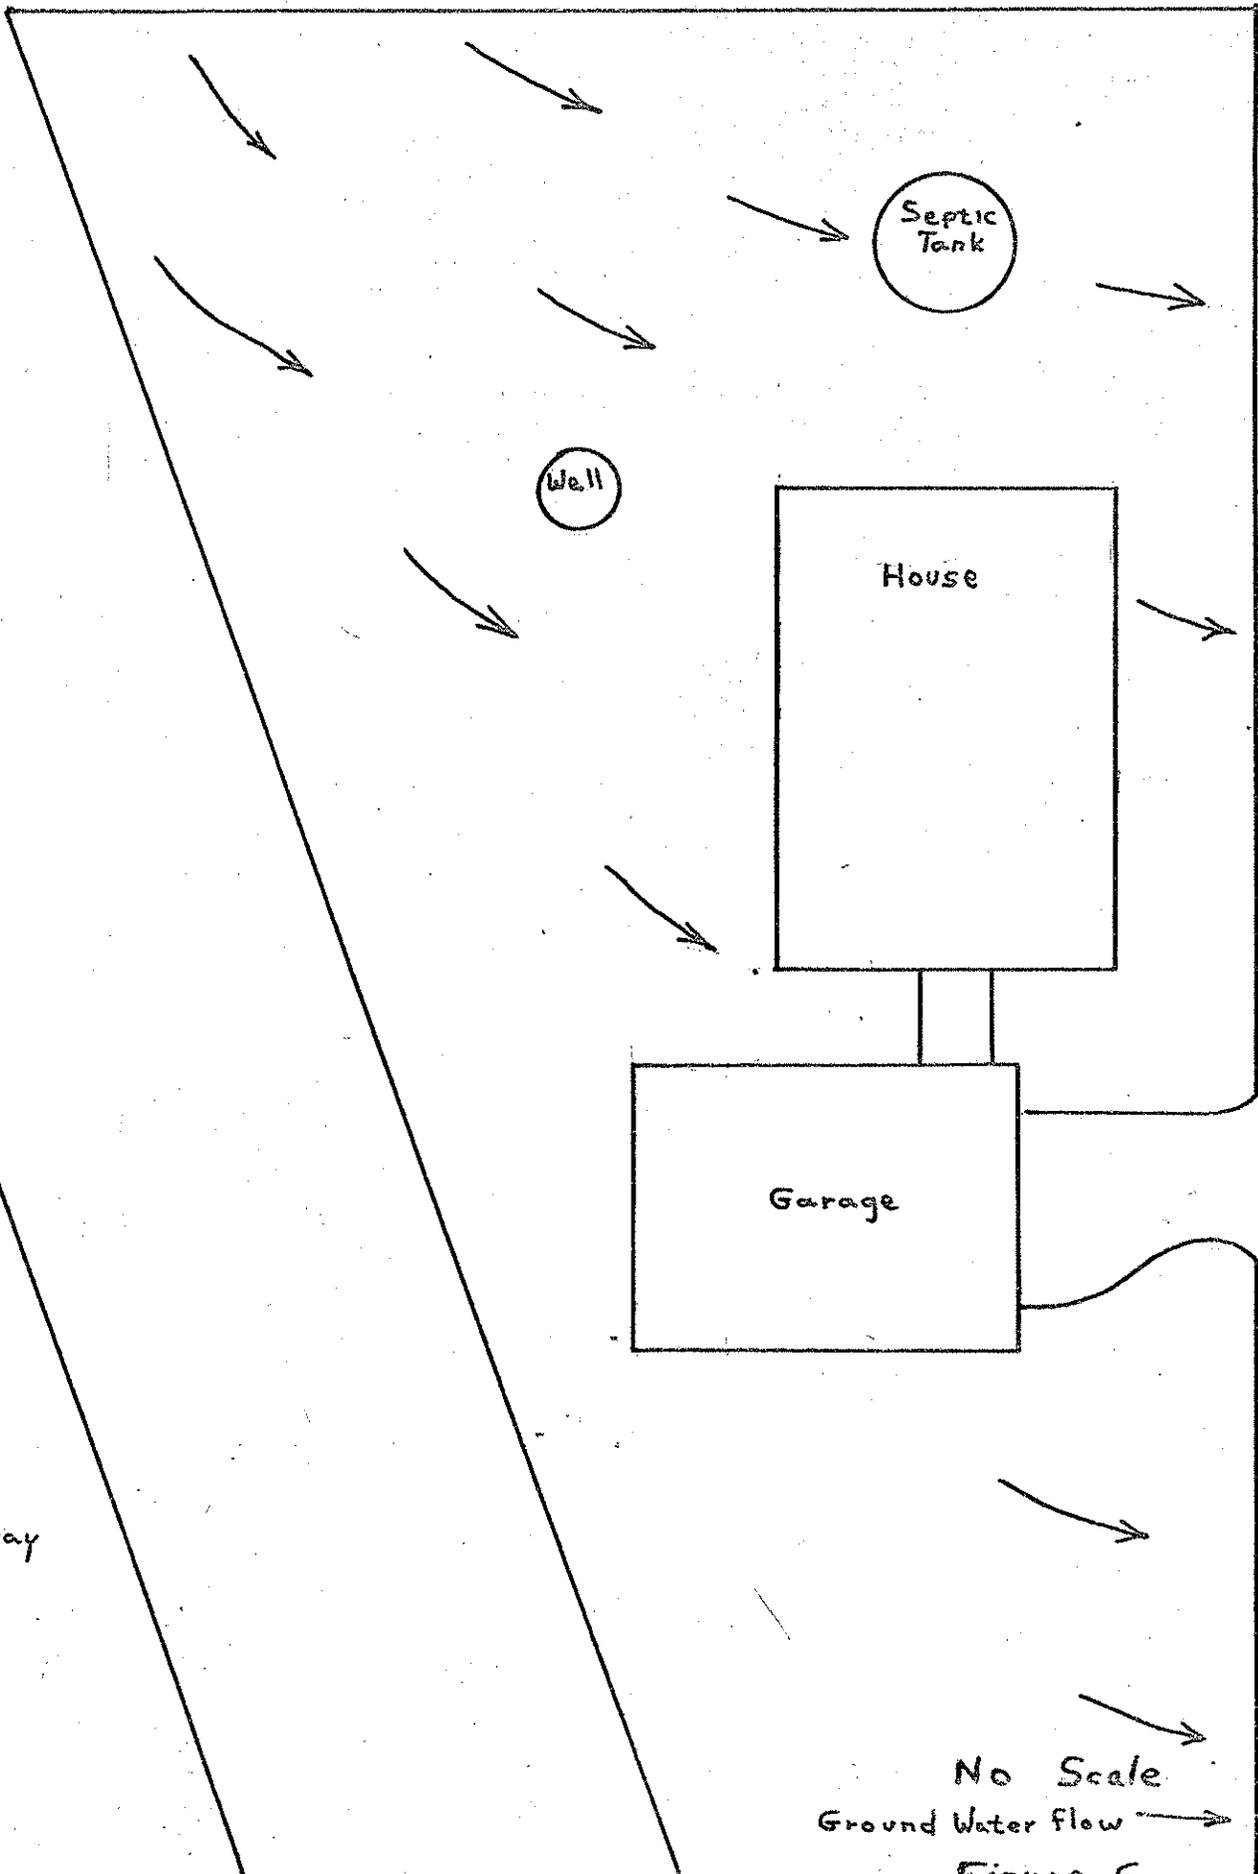
Figure 6

The well in question lies geographically near the southern edge of Snohomish County and is within Section 30, Township 27 North, Range 5 East of the Willamette Meridian, (fig. 1). The altitude of the well is approximately 190 feet above sea level and lies on a relatively flat area with hills raising to the west to an altitude of about 500 feet. The well is located 34 feet west of the northwest corner of the house (fig. 6).

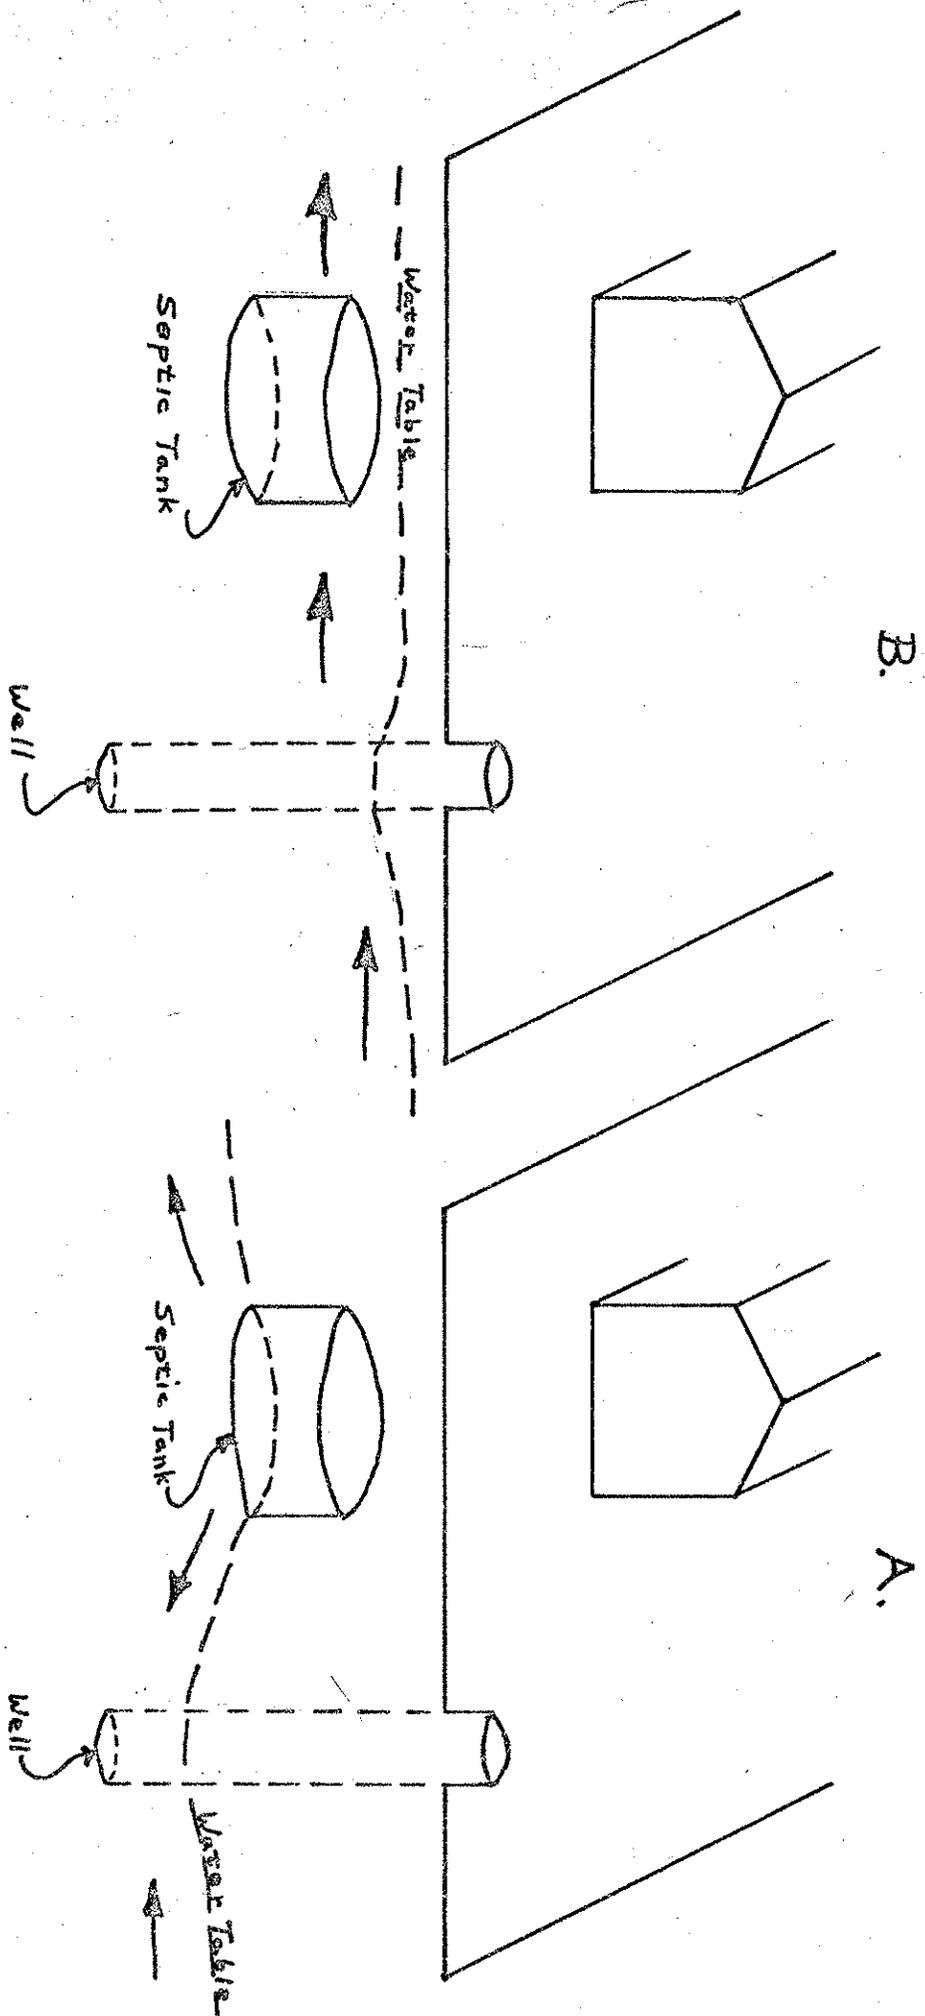
Figure 7

the water level in the well was lowered last summer, which the R. D. Aye report indicated, it is entirely possible that the ground-water gradient in proximity to the well was reversed. This reversal of the ground-water gradient could and probably would occur whenever the water level dropped during the summer months (Figure 7A).

While the septic tank was functioning properly little or no contamination reached the well, however when the malfunction occurred it then allowed pollution to enter the recharge area of the well. When additional water was added to the ground-water system during the winter months the water level would rise to near land surface allowing the ground-water gradient to return to its original course. (figure 7B)

It does appear that pollution due to the septic tank malfunction is the primary source of contamination. When the water level is low in the well the ground-water gradient is locally reversed allowing contamination or recycling of household water to occur.
